Report on and Analysis of Maids Moreton Traffic and Speed Survey

Conducted on
10 to 22 October 2020

Pat Hardcastle for Maids Moreton Parish Council

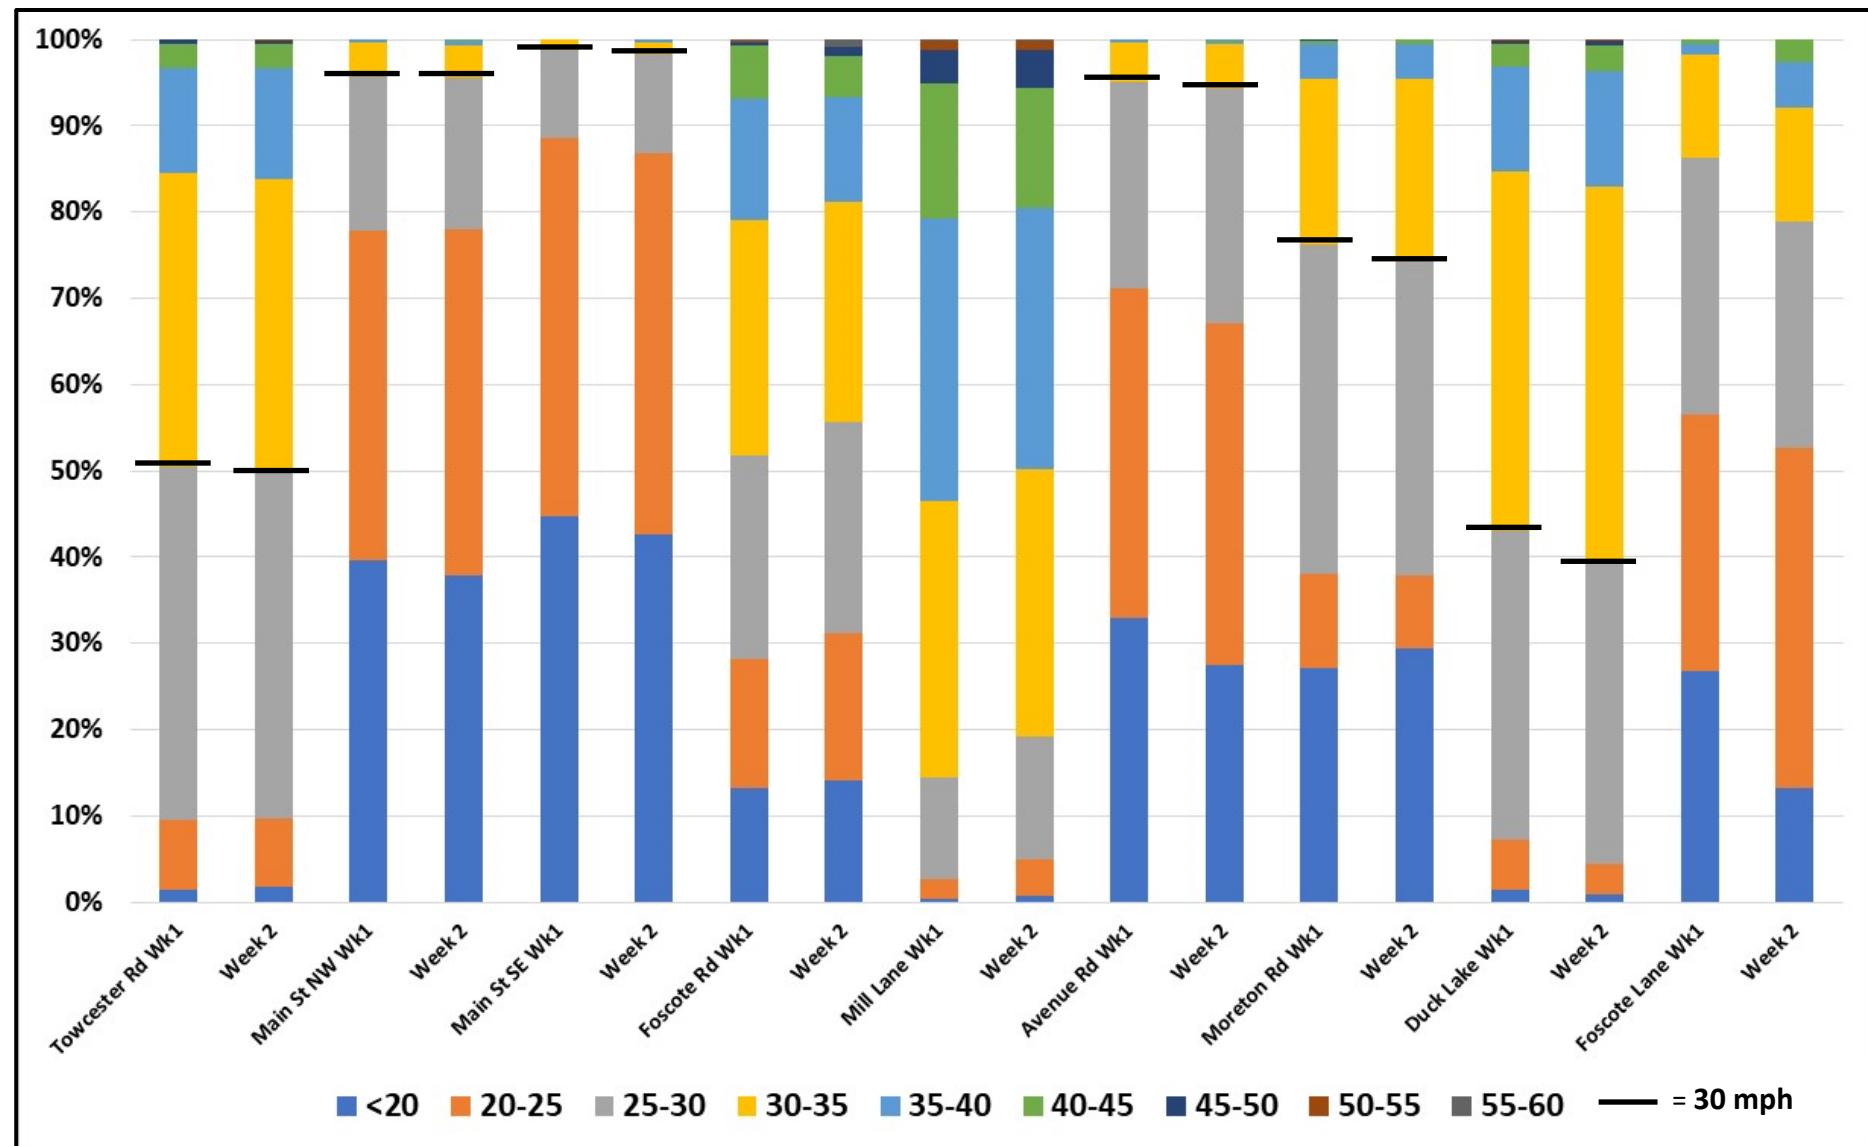
Figure 1 Vehicle Speed by 5mph Bands – South, Southeast or Southwest bound

Table 3 presents the average number of vehicles recorded on weekdays at each location and in both directions for the two weeks separately in speed bands. This table is not easy to follow and the data is presented graphically in Figure 1 and Figure 2. To aid comparison, the data in each speed band is shown as a percentage of the vehicles passing in each direction separately as a stacked bar totalling 100%.

The aim of these two figures is to capture the range of speeds. The black bar across each column is the speed limit, 30mph at all locations except Mill Lane, Foscote Rd and Foscote Lane. While 30mph (60mph on Mill Lane, Foscote Rd and Foscote Lane) is the speed limit, it does not follow that it is safe to drive at 30mph in all situations where it applies.

On Towcester Rd, 50% of the southbound traffic and 75% of the northbound traffic is exceeding the 30mph speed limit. In Duck Lake, 60% of the southbound traffic and 55% of the northbound traffic is exceeding the 30mph speed limit. On Moreton Rd, 25 to 30% of the traffic in both directions is exceeding the 30mph speed limit.

In Main St, which has parked cars and lacks pavements on one and at times both sides, 20 to 30% of the traffic is exceeding 25mph, and there was a significant number of vehicles exceeding the 30mph speed limit during the day, each of which is a potentially fatal accident.

On Avenue Rd, where the Maids Moreton CE [Infant] School is located, only 5% of the southbound vehicles were exceeding 30mph. In part this is because they have just turned in from Moreton Rd but there was also a vehicle parked almost permanently just east of Scott's Lane junction and close to the ATC point. Some 15% of northbound traffic was exceeding the 30mph speed limit here. In addition, there was a worrying number of vehicles driving at grossly excessive speeds, as noted in Table 2.

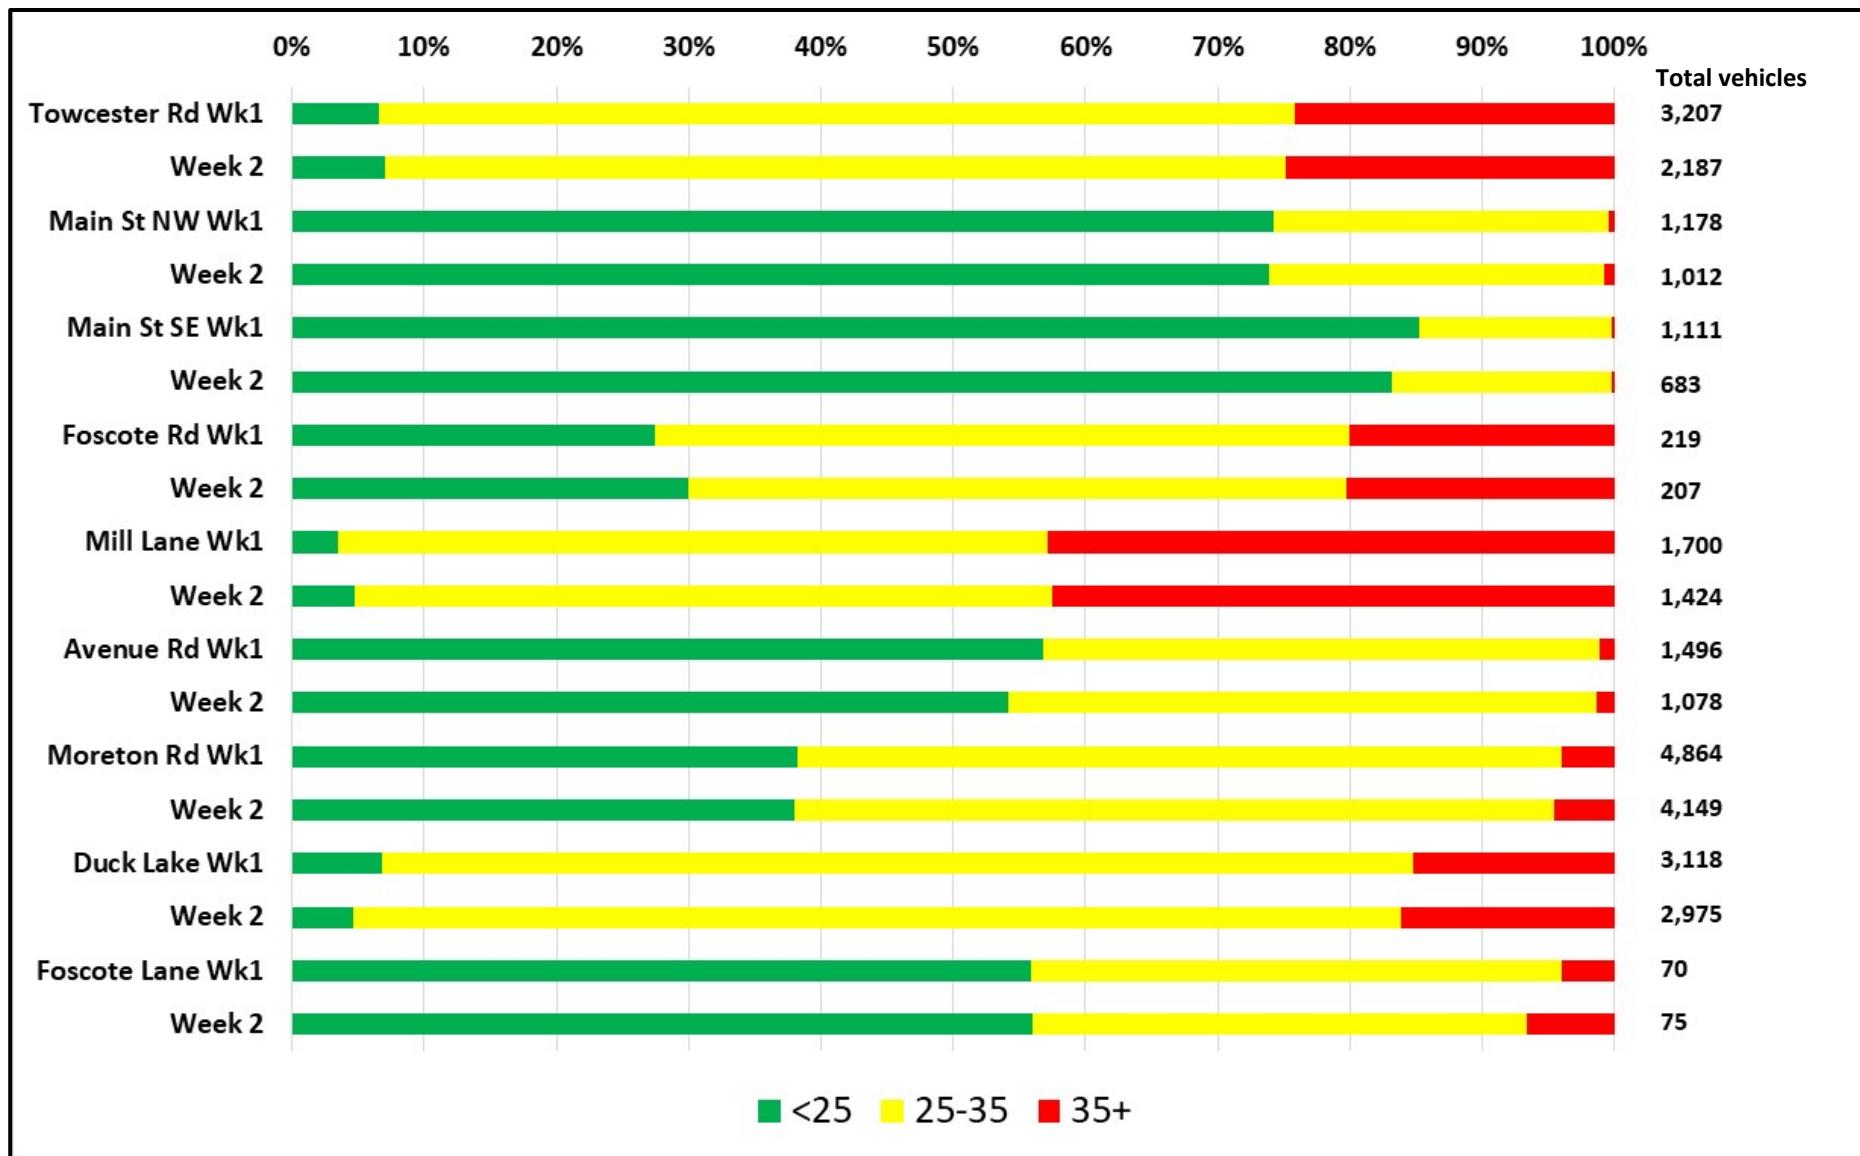
Figure 3 Total Traffic Flow in Speed Bands

Figure 3 presents the traffic flow in three speed bands. The first, up to 25mph is what one might expect were a 20mph limit in place. The second band is 25 to 35mph, the latter figure would be right on the boundary of prosecution for speeding in an area with a 30mph limit ($30 + 10\% = 33 + 2 = 35$). It is apparent that there are problems with speeding well over the 30mph limit on Towcester Rd and Duck Lake in particular.

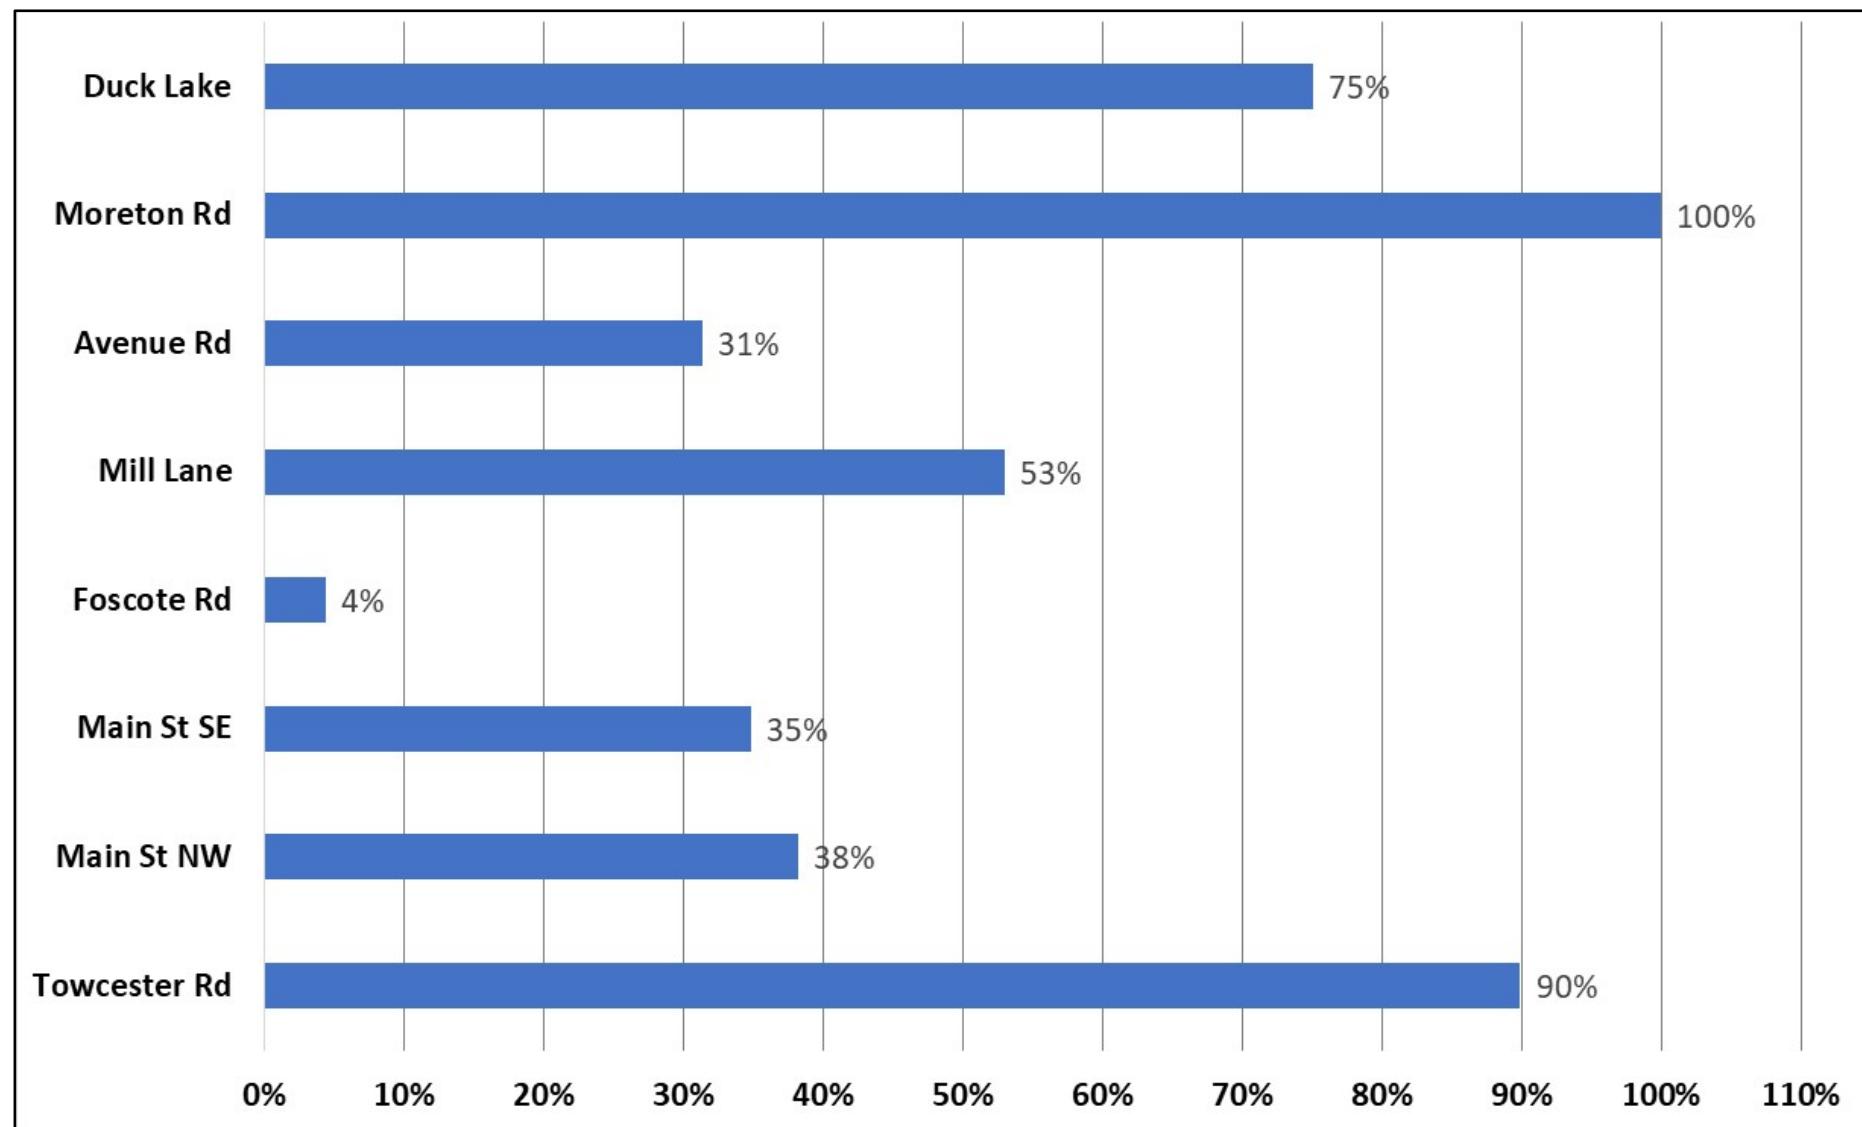
Figure 4 Traffic Flow 0800 - 0900 as % of Moreton Rd

It is clearly evident from Table 1 below that current traffic levels are below those recorded on December 2018, likely as a result of Covid-19 restrictions changing working patterns. It is, however, interesting to look at the comparative flows along roads of different types and in different settings. The A413 between Buckingham and Towcester runs through Maids Moreton as Moreton Rd, Duck Lake and Towcester Road; the Moreton Rd ATC recorded the highest traffic flow. Figure 4 below shows the relative volume of traffic during the morning peak period of 0800 to 0900 at each of the ATC locations compared with the figure recorded at Moreton Rd, which is given a score of 100%.

Moreton Rd (100%) and Towcester Rd (90%) ATCs recorded similar volumes of traffic while Duck Lake recorded 75% of the Moreton Rd figure. Traffic recorded at Moreton Rd may divert or join at Avenue Road and Main St, which is why Duck Lake has the lowest value of the three ATC points on the A413. Main St traffic may also head north on Towcester Rd.

Traffic levels along Main St are 35% (SE) and 38% (NW) of that recorded on Moreton Rd. Main St is narrow, has no or only one pavement along much of its length and as many of the houses have no off-road vehicle parking spaces, there are many cars parked on the street, making it effectively a

On Avenue Rd, past the Maids Moreton CE [Infant] School the traffic flow is 31% of that on Moreton Road. Again, there are often parked cars although walking to school is strongly encouraged and many children do so. Maids Moreton CE [Infant] School is on Avenue Rd and Buckingham Primary School in Page Hill, south of Avenue Rd. Pupils from Maids Moreton accessing both schools on foot have to cross Main St and those heading to Buckingham Primary then also have to cross Avenue Rd, their safety is of course of paramount importance. In Avenue Rd, around 45% of the traffic was travelling at more than 25mph. Given the Maids Moreton school is there and children attending Buckingham Primary school have to cross Avenue Rd to access this, there is very urgent need for effective calming. This can be addressed as part of the ongoing school extension work.
